The 30 September 2009 “Padang” Earthquake

Dick Beetham GNS Science

6 October 2009

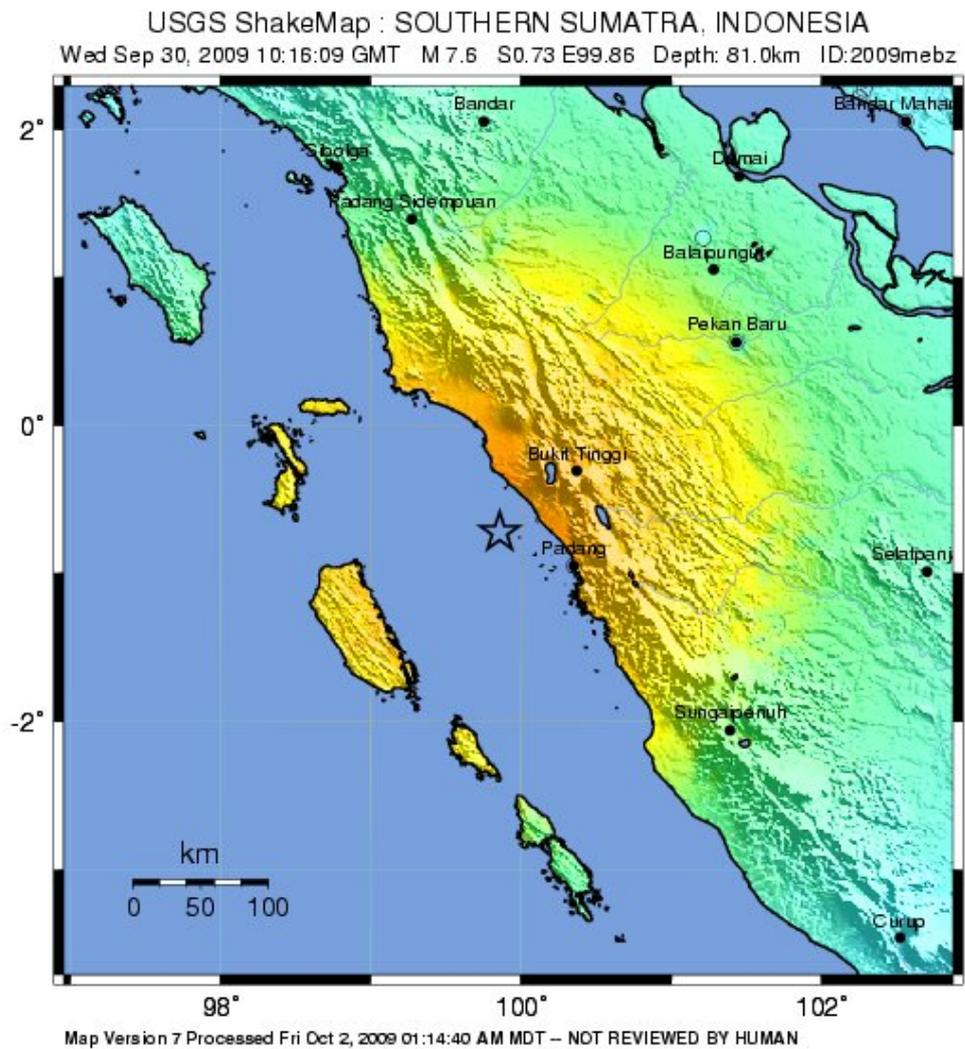
Figure 1. The USGS Shake Map shows the earthquake epicentre and gives a MM Intensity of 7 to 8 in Padang

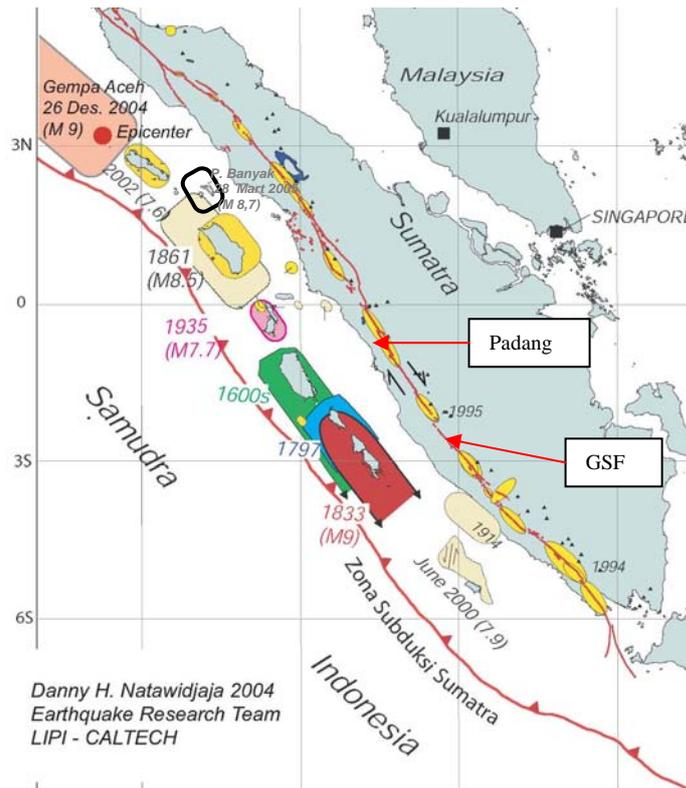
Figure 1. Map of tectonics and major earthquake sources of the Sumatran Plate Margin. The yellow ellips along the Sumatran Fault Zone are ruptures of the past earthquakes. The numbers indicate years of occurrences. Colored rectangles offshore the Sumatran west coast indicate major seismic sources beneath the ocean, on the subduction interface.

Figure 2. Source areas of earthquakes of the Sumatra region. The yellow zones along the Sumatran Fault are also historic earthquakes.

A second earthquake, which measured 6.6 M_w , struck the province of Jambi in central Sumatra, 08:52:29 local time on 1 October 2009 at a depth of 15 km, about 46 km south-east of Sungaipenuh. This earthquake appears to be on or close to the trace of the Great Sumatran Fault, which is also a regular source of earthquakes. (Figure 2)

The subduction zone surrounding the immediate region of this event has not witnessed a megathrust earthquake in the recent past, rupturing last in an earthquake of M 8.5 or larger in 1797. Approximately 350 km to the south, a 250 km section of the plate boundary slipped during an M_w 8.4 earthquake in September 2007, while approximately 300 km to the north, a 350 km section slipped during the M_w 8.7 earthquake of March 2005. In early 2008, the plate boundary up-dip of today's earthquake was active in a sequence of M_w 5-6 earthquakes. It is not clear how today's earthquake is related to the sequence of mega thrust subduction zone events on the shallower section of the plate boundary (Figure 2).

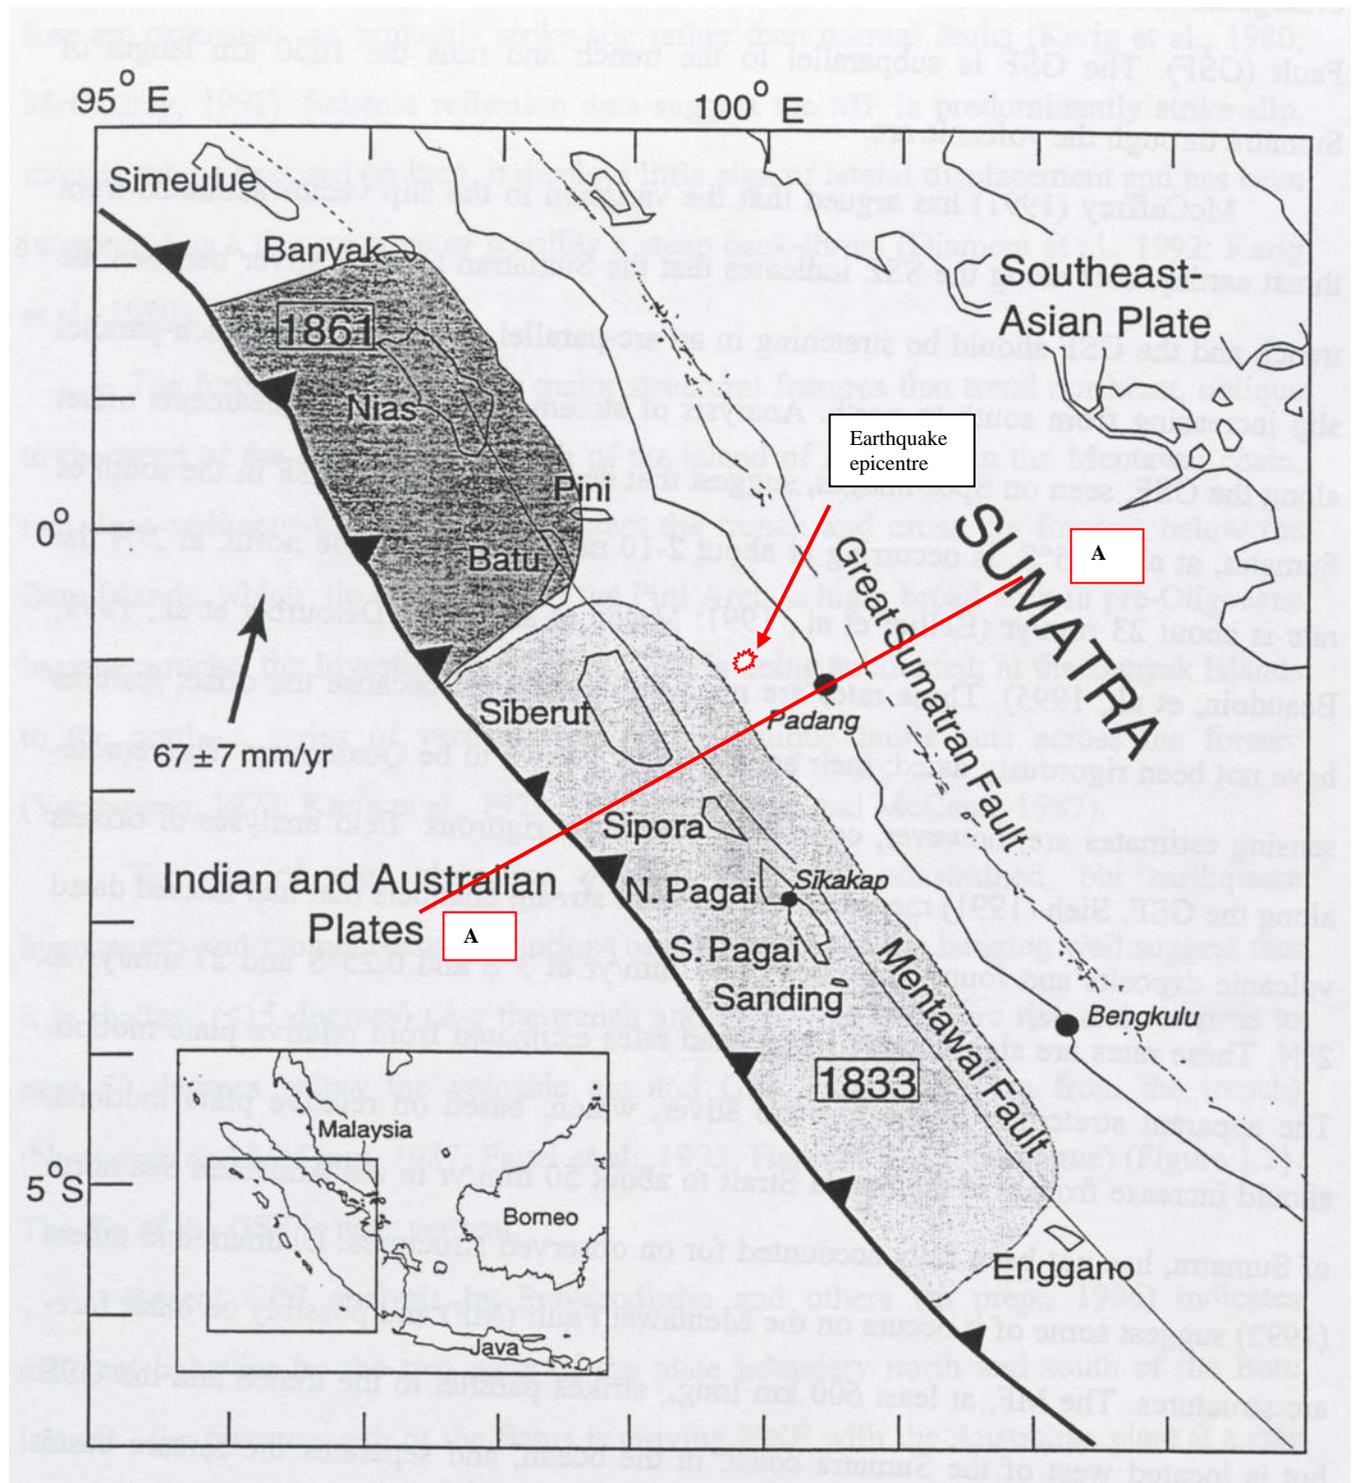
Figure 3. The previous Great earthquakes on the subduction zone were in 1866 under Nias on the Nias Segment and in 1833 under the Mentawai Islands on the Padang Segment. The Nias Segment has already ruptured again in the Great Nias Earthquake of 28 March 2005, and there is a high probability of a great earthquake on the Padang Segment in the coming (10's of) years as it is already ~180 years since the previous event and accumulated strain is about 11 m (from PhD thesis by Judy Zachariassen).

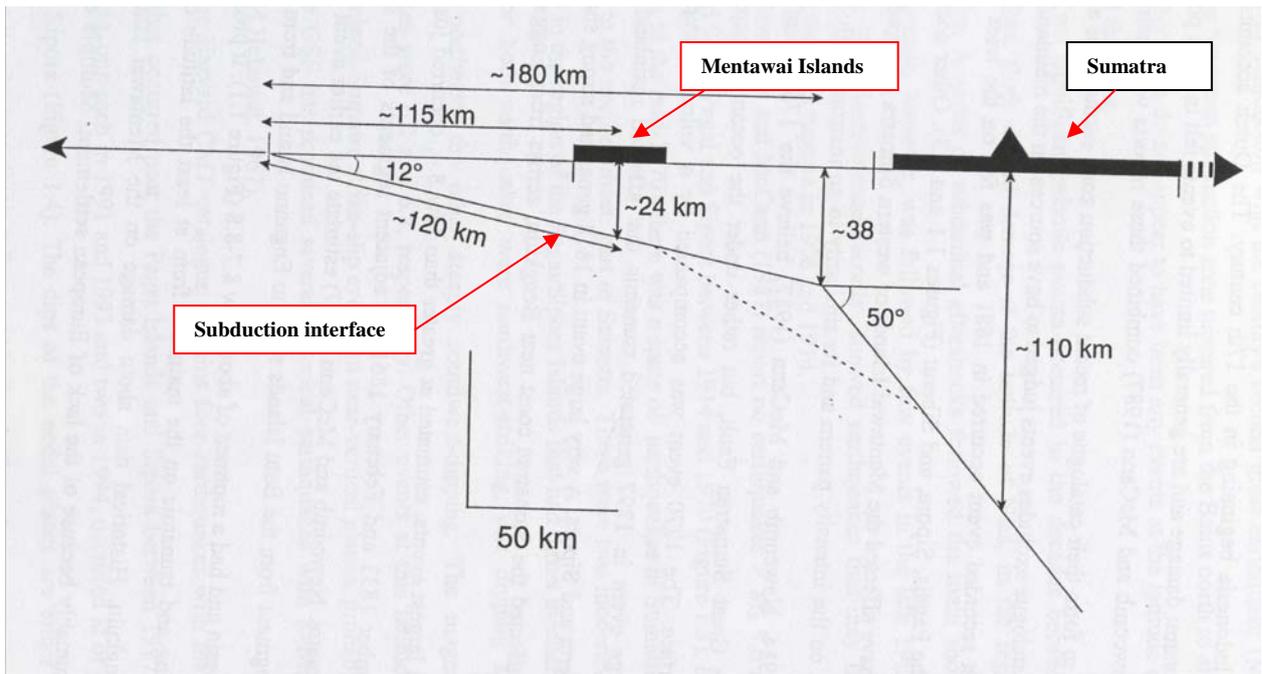
Figure 4. Section A – A. The Great Subduction Zone earthquakes occur on the subduction interface this is 20 to 24 km below Mentawai Islands. In the ~180 years between the 1833 and 2009, approximately 11m of strain has accumulated (60mm/yr over 180 yrs = ~11m) if the subduction interface is locked. This strain would be released by sudden rupture movement along the subduction interface, as was the case during the Great Nias Earthquake of 28 March 2005.

Figure 5. A cross-section by the USGS through the subduction zone at Padang, showing the subduction interface (dotted red line) and the focus, at 80km depth below the centroid of the Padang Earthquake. Compare this Figure with Figure 4.

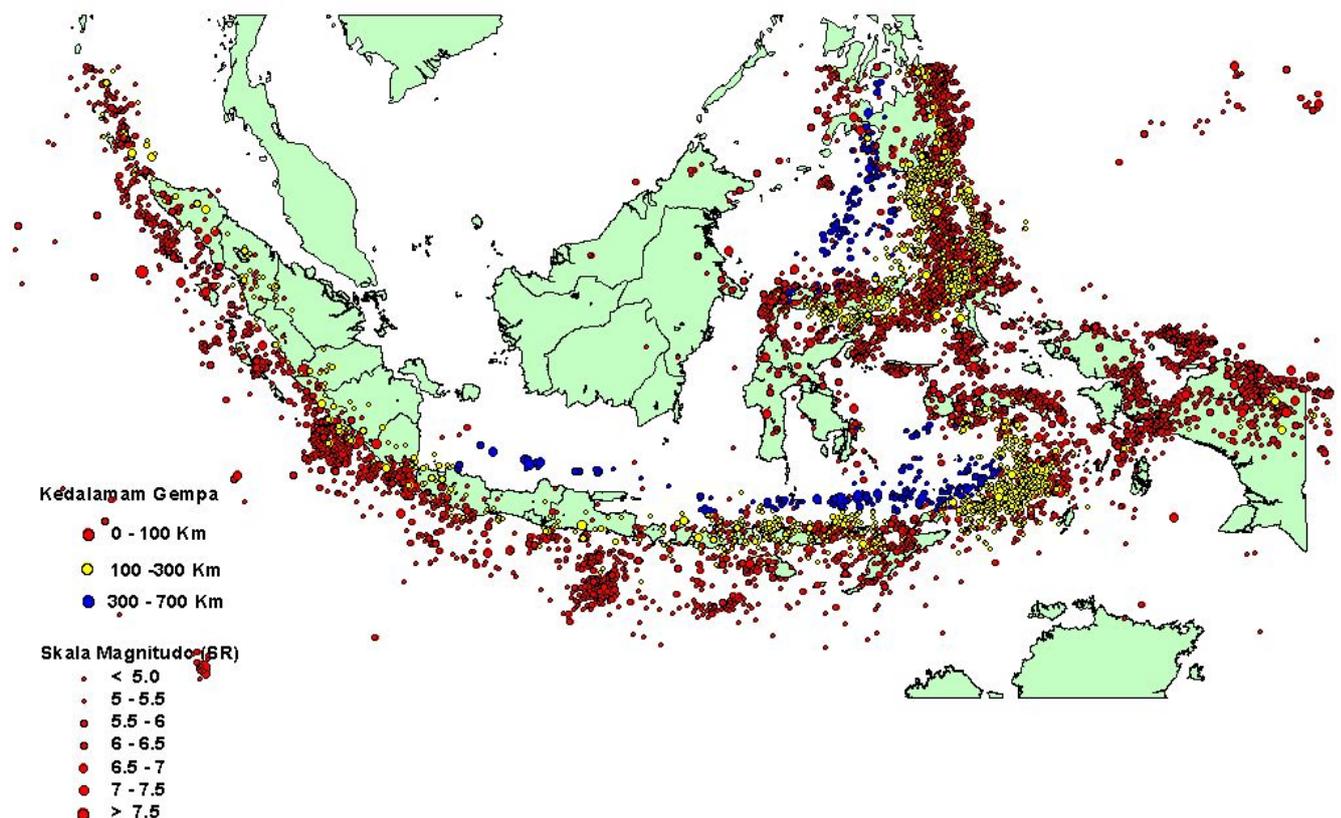
Figure 7. A sample of Indonesian seismicity – with colours showing depth. Red dots are shallower earthquakes (0 to 100 km deep) and blue are the deepest (300 to 700 km deep), outlining the subducting Australian Plate as it descends beneath the Sunda Plate – which in this location is the Indonesian and Malaysian land masses seen above.

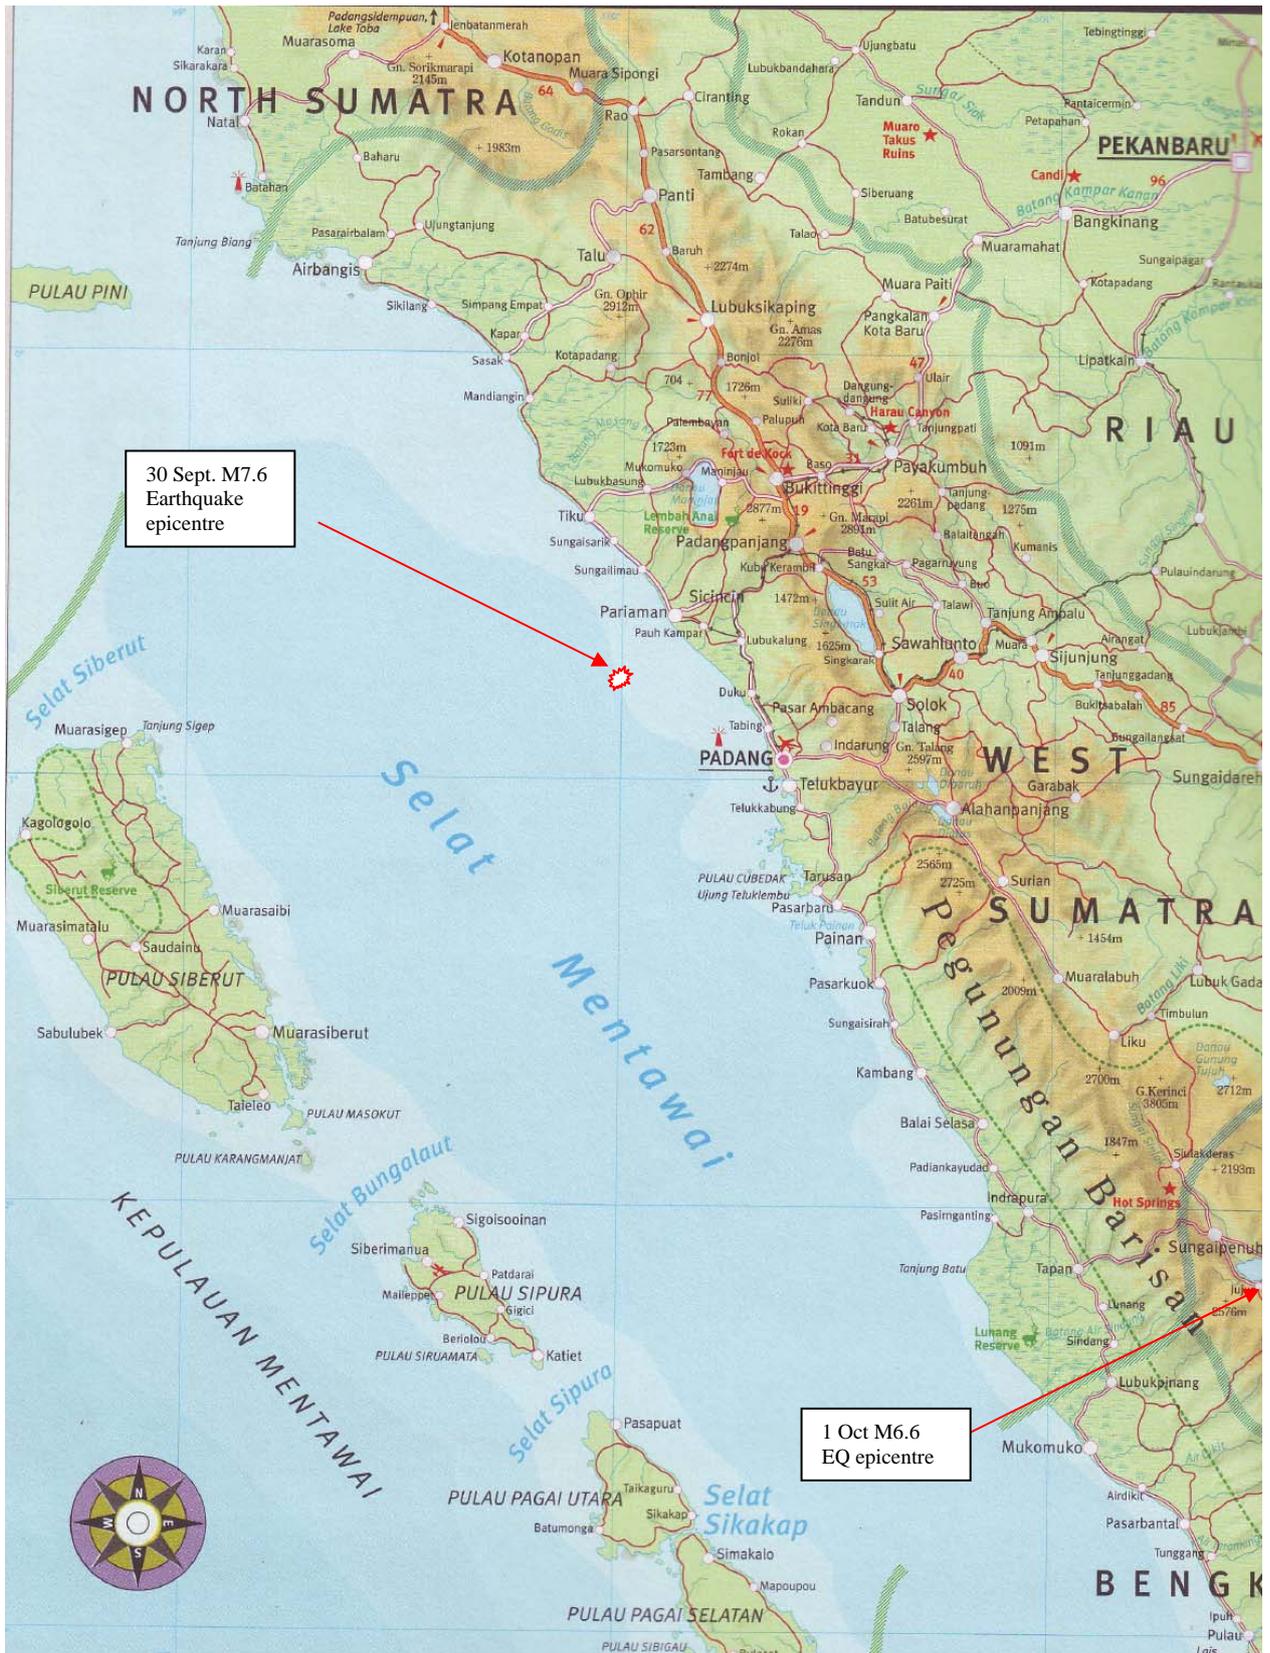
Figure 8. Relief map of the earthquake area. The lineament of the Great Sumatran Fault can be followed from Sungaipenuh in the south, through Liku, Muaralabuh, Surian, Solok, Lake Singkarak, Padangpanjang, Bukittinggi, Lubuksikaping, Panti.

Padang is located on a coastal strip of geologically sediments which have been deposited by rivers with their source in the volcanic mountains to the east (Figure 8). These rivers meander across the low-lying coastal strip, depositing fine-grained sediments and in places forming swampy ground, over which the city of Padang has now spread. The accumulated deep soils of the swampy coastal strip are likely to be classed as D (deep or soft soil sites) and E (very soft soil sites) in terms of NZS 1170.5 2004. News reports from Padang after the earthquake suggest that there may have been both liquefaction and ground amplification of the seismic waves - which were particularly damaging to taller buildings, with a longer natural period? Eye witnesses are describing visible ground waves from the earthquake.
