Seismic Stability of the Mt. Frederick Sidecast

C.W. Krumdieck

MWH NZ Ltd., Christchurch, New Zealand.

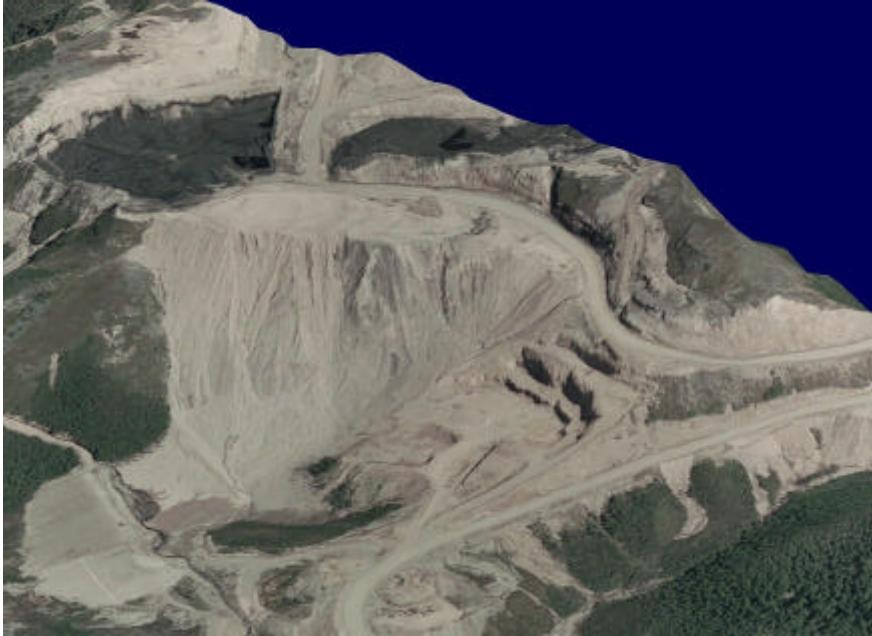
The sidecast contains approximately 3 million cubic meters (m³) of materials that were end-tipped into an area on the northeast face of Mt. Frederick and the upper Herbert Stream catchment. Below the sidecast, a sediment retention dam was constructed to control and divert stormwater and sediment runoff from entering Herbert Stream. A recent aerial photo of the sidecast is shown in Figure 2.

Figure 2 - Aerial view of the existing Mt Frederick Sidecast

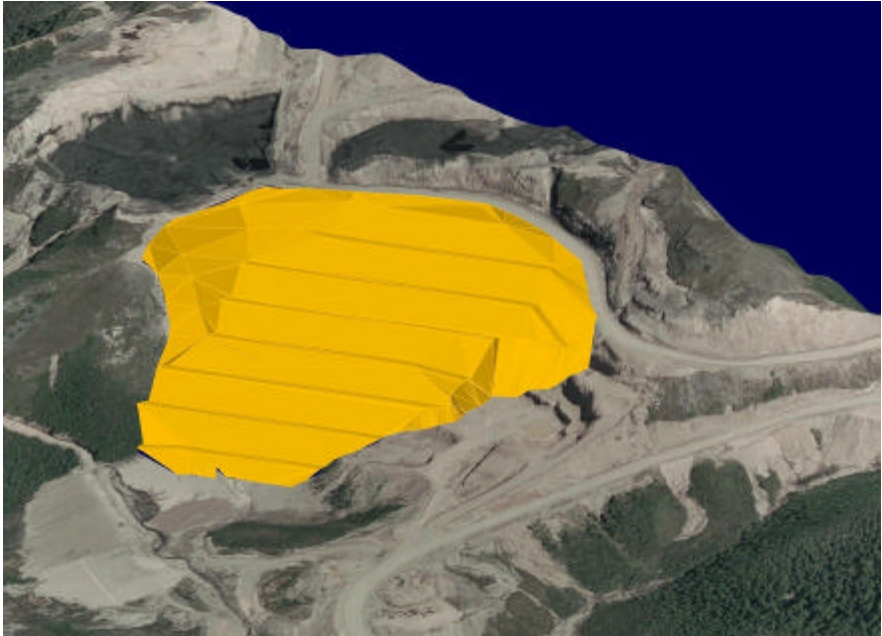
The intent of preliminary layouts was to make the reconfiguration a balanced cut to fill operation and retain all of the overburden materials within the Herbert Stream catchment. However, it soon became apparent that this would not be possible without placing a significant quantity of materials on the potentially liquefiable sediments. Analysis of the liquefaction potential using methods by *Seed* and *Davis & Berrill* confirmed the susceptibility of the saturated sediments to liquefaction at the OBE level of shaking, therefore any material placed on the sediment was likely to be severely disturbed during seismic shaking. Other treatment options (such as densification, drainage, etc.) were investigated, and found to be prohibitively expensive for the scale of the site, the decision was made to place as little of the reconfigured stockpile on the impounded sediments as possible. Solid Energy agreed that a large volume of materials would have to be removed from the Mt Frederick site to achieve this goal. The proposed remedial earthworks will consist of flattening and recontouring the sidecast to create a stepped landform by a series of 10m wide benches spaced on 15m vertical intervals with 2.7H:1V batters slopes to produce an overall slope of 3.3H:1V as shown on figure 3.

Figure 3 - Computer-generated view of proposed reconfigured sidecast.

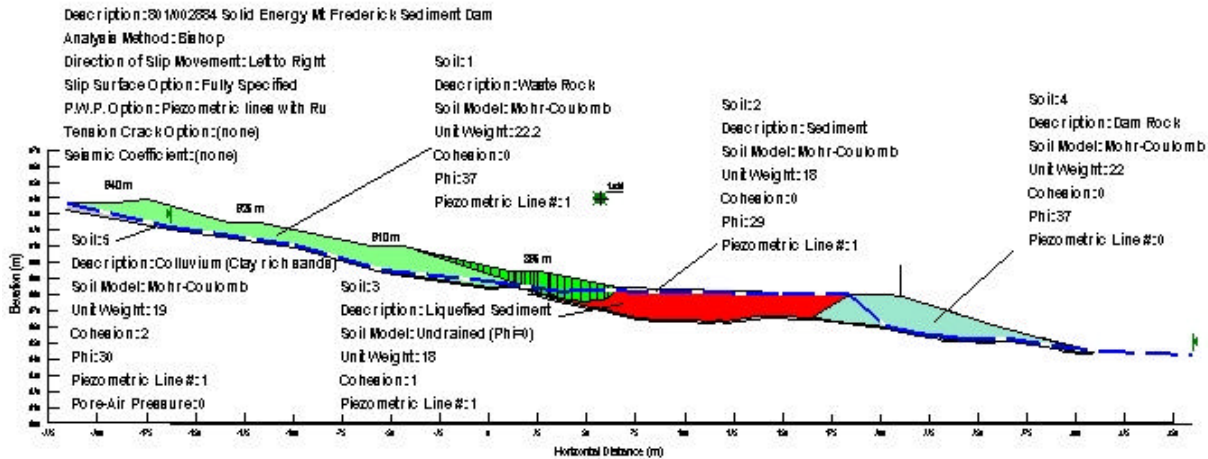
The aims of the final analysis was to: confirm the static stability of a “global” failure (i.e. a failure involving more than simply a shallow skin of material either on the dam or the stockpile); establish the relative size of failure that could be induced by the liquefaction of the impounded sediments; and confirm that the portion of the stockpile that was not affected by liquefaction also complies with the seismic design requirements. An example of the slope stability model used for this analysis is shown in Figure 4.

Figure 4 - Example of Stability Analysis output

This model represents the situation of the soil being in a liquefied state but without an external applied acceleration. Any failure surface with a FOS less than one under these conditions cannot resist the continuous static stresses and will fail. Surfaces that include less of the rockfill than shown in Figure 4 would also have a FOS less than one and would be expected to slump. It should also be noted that during the earthquake, after the sediments have liquefied, there would be instantaneous failures during the earthquake pulses along the failure surface shown that will result in significant deformations. It was therefore necessary to apply some judgement to the further extent of the slope that would undergo so much deformation as to have essentially failed. Results of the analysis are summarised in Table 4:
